BUILDING-STRUCTURE INVENTORY FORM

& HISTORIC PRESERVATION	QUAD
DIVISION FOR HISTORIC PRESERVATION	SERIES
(518) 474-0479	NEG. NO.
YOUR NAME: Cynthia Howk	DATE: Dec., 1994
133 S. Fitzhugh St.	546-7029
YOUR ADDRESS: Rochester, NY 14608	TELEPHONE:
ORGANIZATION (if any): The Landmark Soc	iety of Western New York, Inc.

* * * * * * * * * * * * * * * * * * * *	
	* * * * * * * * * * * * * *
IDENTIFICATION 1. BUILDING NAME(S): Pieper House	
2. COUNTY: Monroe TOWN/CJTY: G 3. STREET LOCATION: 1560 Edgemere Drive	reece VILLAGE:

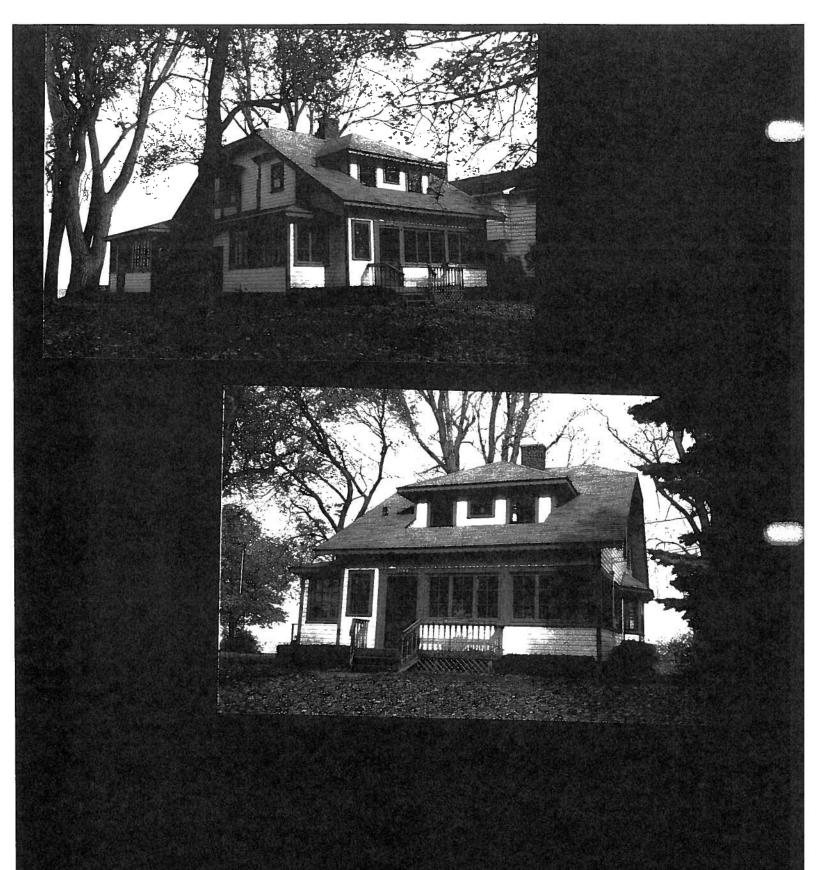
c. list major afterations and dates (if k	liown):
(See continuation sheet)	
12 PHOTO.	
12. PHOTO:	3. MAP:

The contemporary front porch, railing, and steps appear to date from the 1980s.

The sliding glass windows which enclose the front, side, and rear porches may have been added after the original date of construction. Probably installed by the 1940s, these windows are now part of the historic design of the house.

18. This 2-story residence has horizontal, shiplap wood siding and (probably) a concrete block foundation (not visible). It features a broad-pitched, side-gable, jerkin-head roof with a shed-roof front dormer. The fenestration is asymmetrical and windows are principally 1/1 double-hung sash. A brick chimney sits atop the ridge pole of the main roof. A decorative, scallopped-edged board extends along the eaves of the front dormer, east window bay, and front, west (side) and north (rear) porches. Window bays are located on the east elevation (an angled bay) and the west elevation (an angled bay and a square bay).

There are three fully enclosed porches on this residence; they are located on the south (front), west (side), and north (rear) elevations. All three porches are characterized by the same design elements: a solid, knee wall on the lower half, square wood posts, and sliding, 6-paned, wood windows that fully enclose each

porch from the weather. Decorative wood screens with straight lattice are located underneath each of the porches. Contemporary steps, deck, and railing have been constructed by the front (north) door.
